NASA Contractor Report 145326

Flight Service Evaluation of  
Kevlar-49 Epoxy Composite  
Panels in Wide-Bodied  
Commercial Transport  
Aircraft - Fourth Annual  
Flight Service Report

LOCKHEED-CALIFORNIA COMPANY  
BURBANK, CA 91520

April 1978

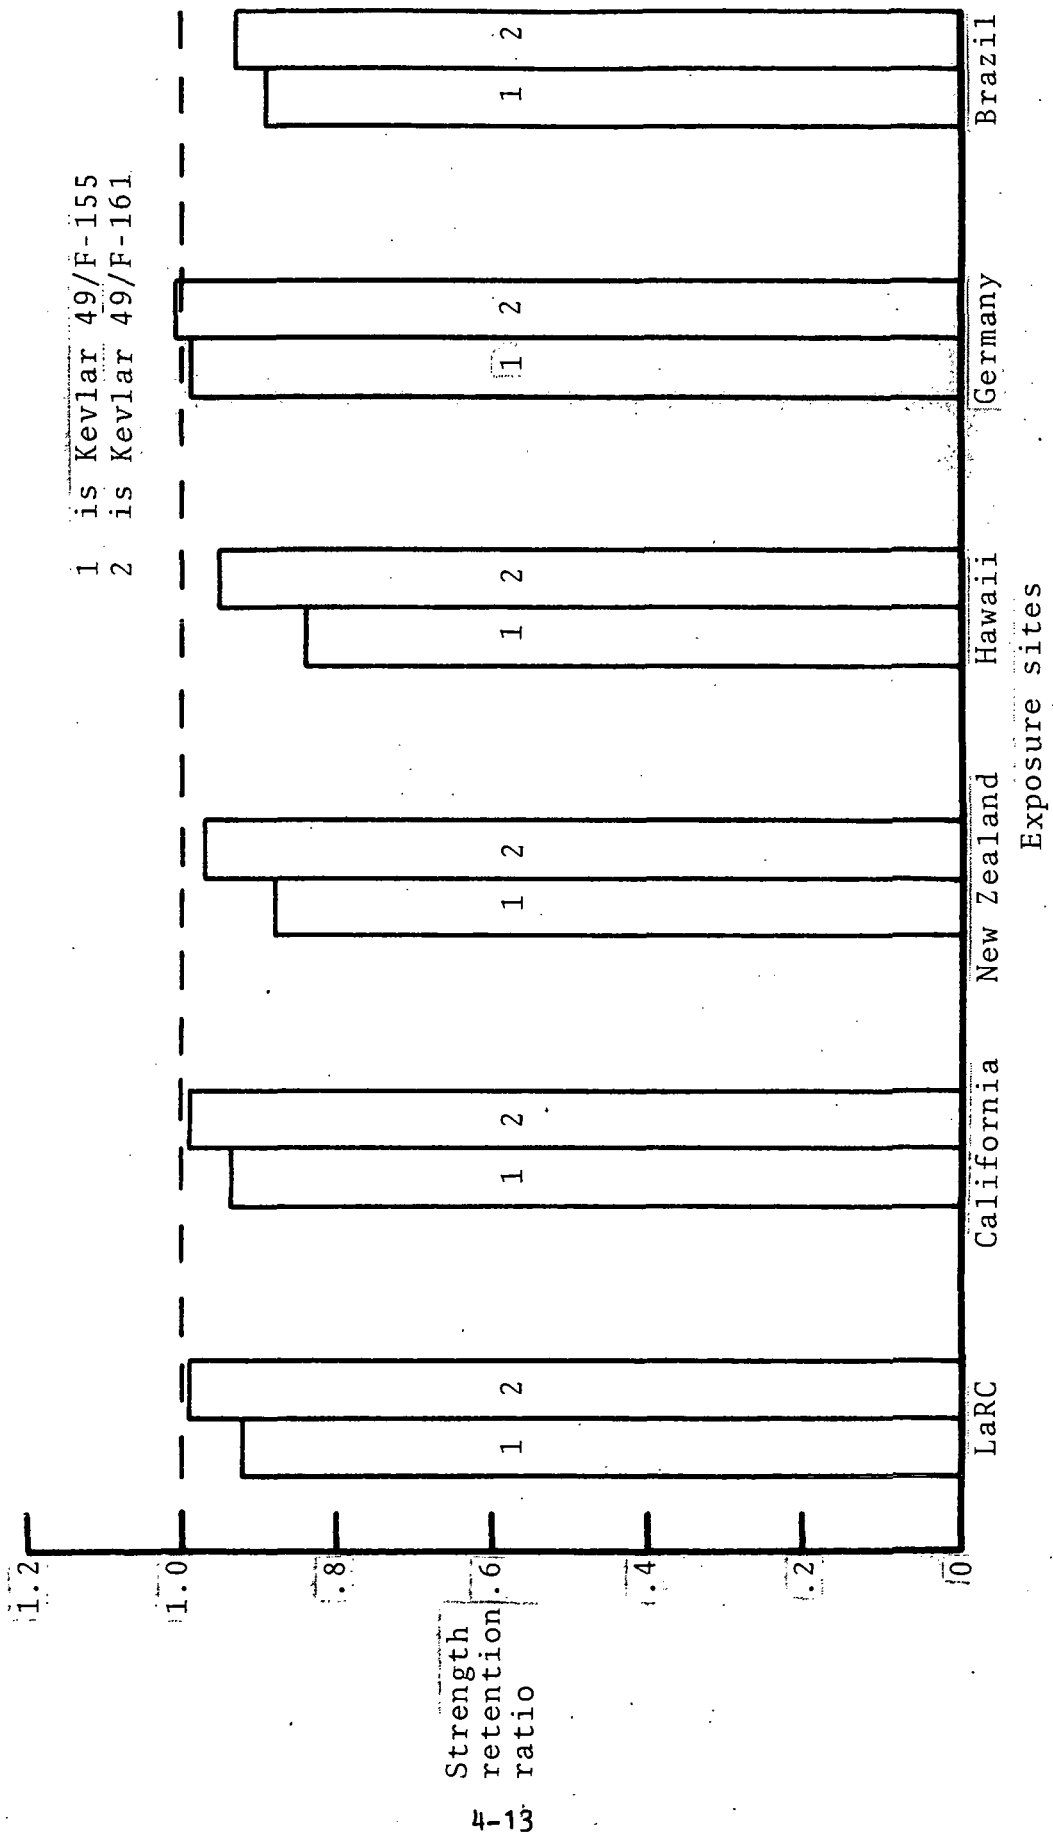
strength retention for the Kevlar-49/F-155 Hawaii specimens is shown in Figure 6. Very little strength changes have occurred for the Kevlar-49/F-161 flexure specimens after 3 years exposure at all six locations as shown in Figure 6.

Figure 6. RT Flexure Strength Retention of Kevlar/Epoxy After 3 Years Outdoor Ground-Based Exposure

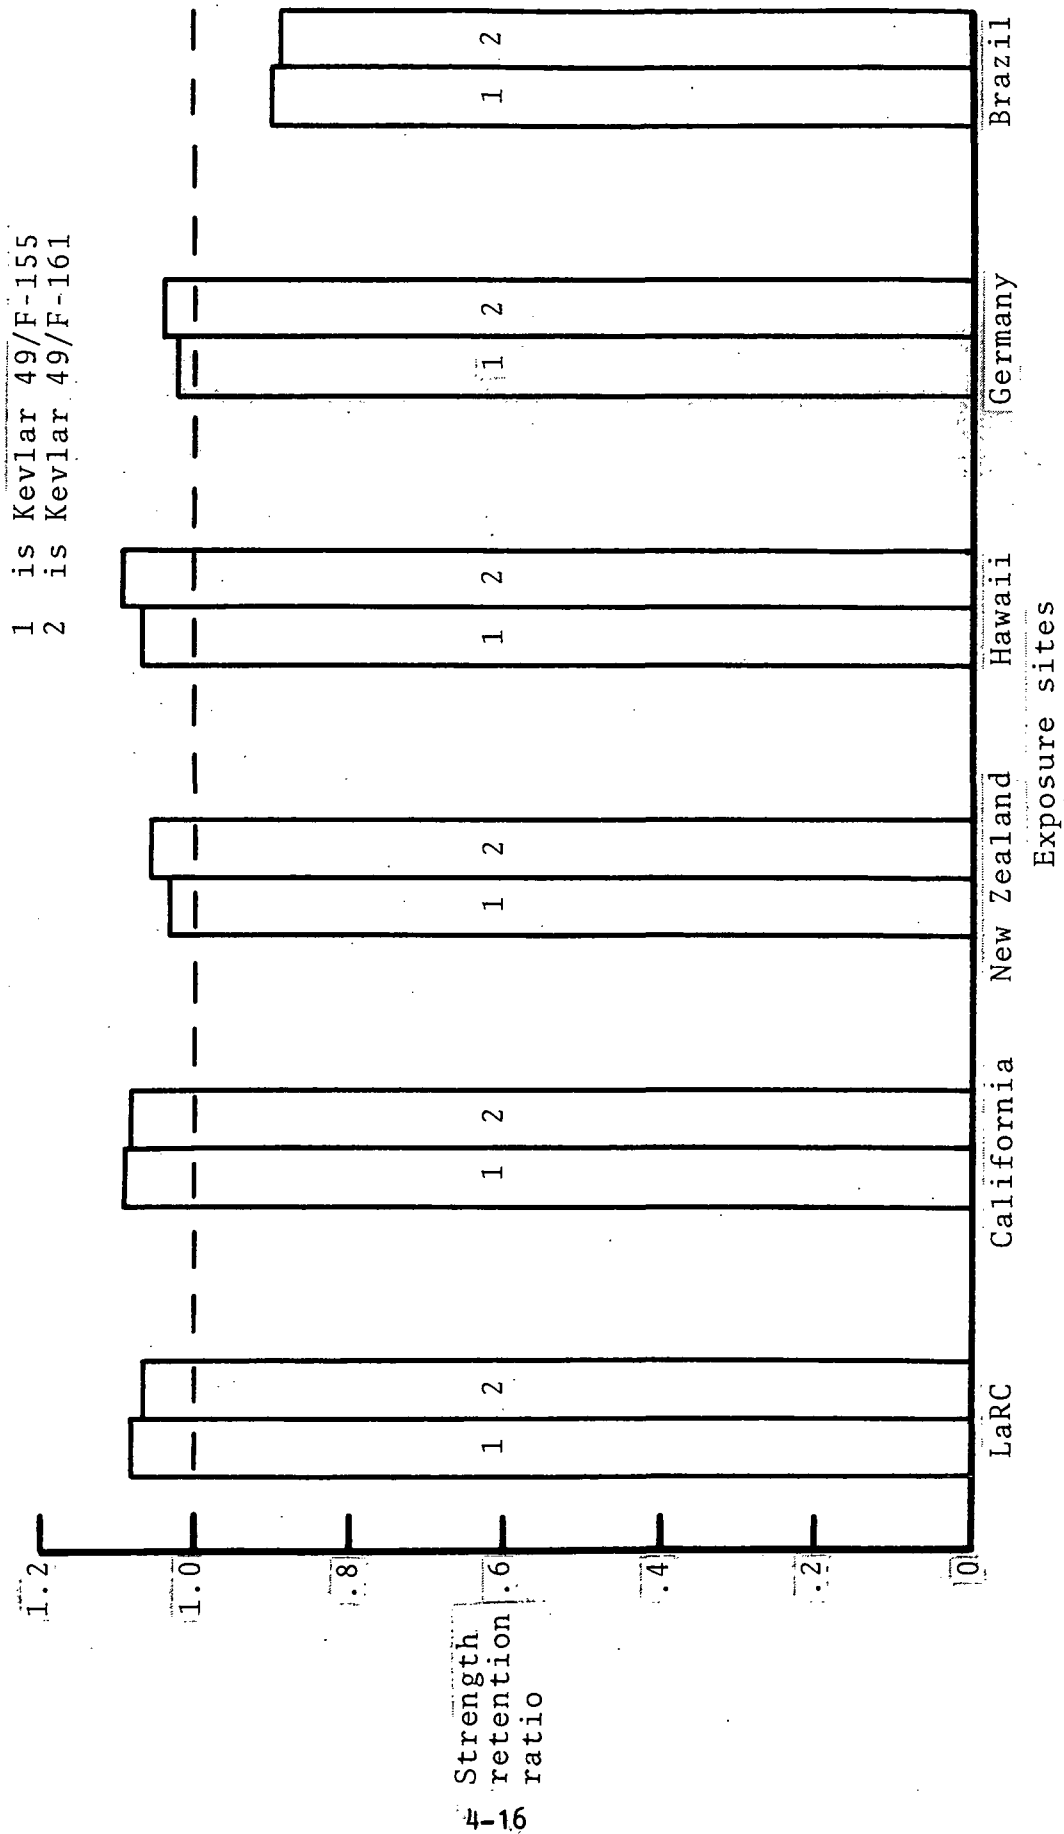
The 1 year compression strength increased compared to the baseline except for the specimens exposed in Brazil which showed a 10 percent strength reduction as shown in Figure 9. The 3 year compression strength decreased except for the specimens exposed in Brazil which showed a 2 to 4 percent strength increase compared to the baseline specimens as shown in Figure 10. Scatter in the data and a limited number of tests are probably the cause of variations in data trends.

Figure 9. RT Compressive Strength Retention of Kevlar/Epoxy After 1 Year Outdoor Ground-Based Exposure

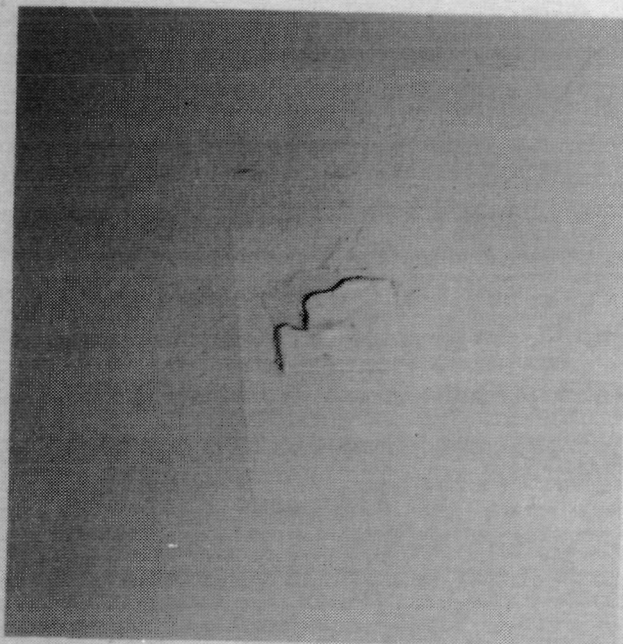
- 3) The tape patch noted in the 1975 and 1976 inspections was still in place, unchanged in appearance since the 1976 inspection. (Figure 11)
- 4) A delaminated area 1.9 cm. by 19.1 cm. (3/4 inch by 7 1/2 inch) was observed on the inner surface unchanged in appearance or extent since it was observed in the 1975 inspection.

Figure 11. Eastern LH Wing-Body Fairing - External Tape Patch

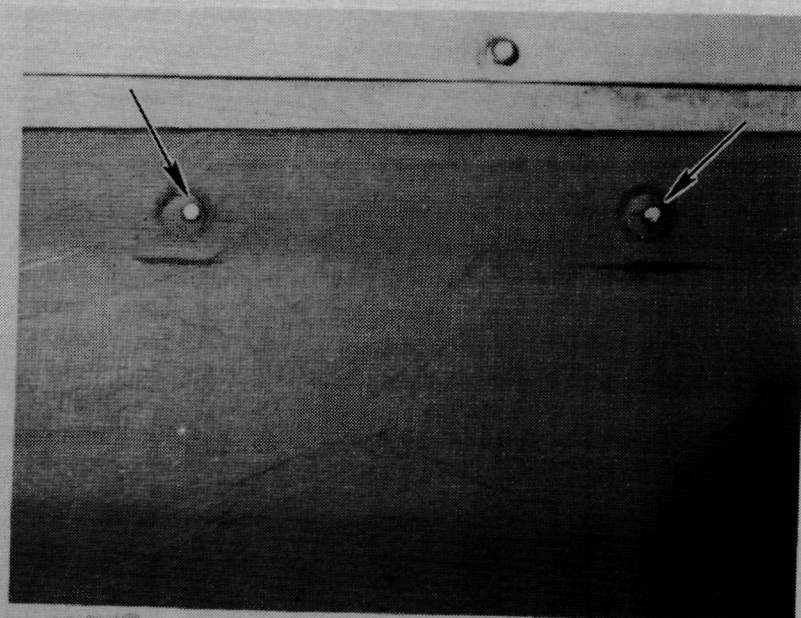
- 5) Slight fraying of the fastener holes was visible from the exterior on all four edges, with more fraying noted on the bottom edge. Heavier fraying was noted on three holes, one on the top edge and two on the aft edge. (Figure 12)

Figure 12. Eastern LH Wing-Body Fairing - Frayed Fastener Holes, Lower Aft Edge on Inner Surface

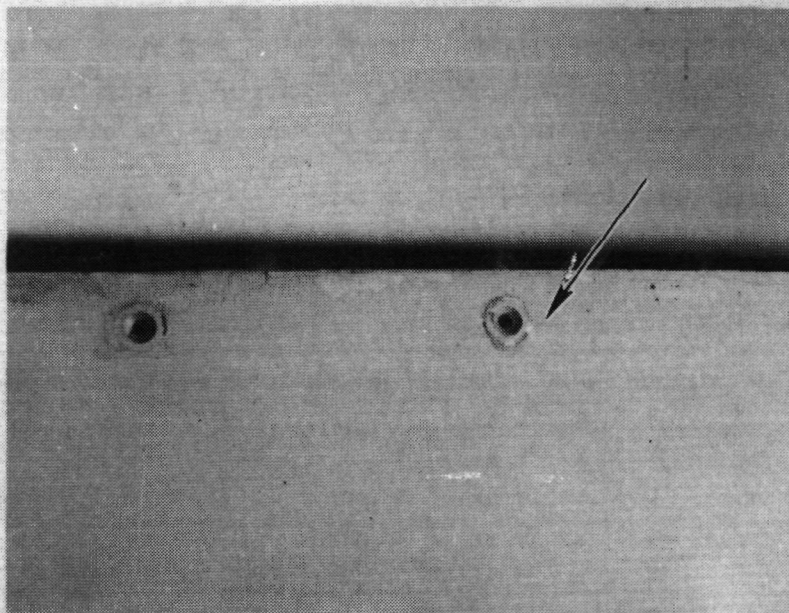
- 7) Considerable paint chipping and re-painting was noted around the fastener holes. (Figure 13)
- 8) No evidence of Skydrol contamination.

Figure 13. Eastern LH Wing-Body Fairing - Paint Loss Areas Around Fastener Holes, Exterior

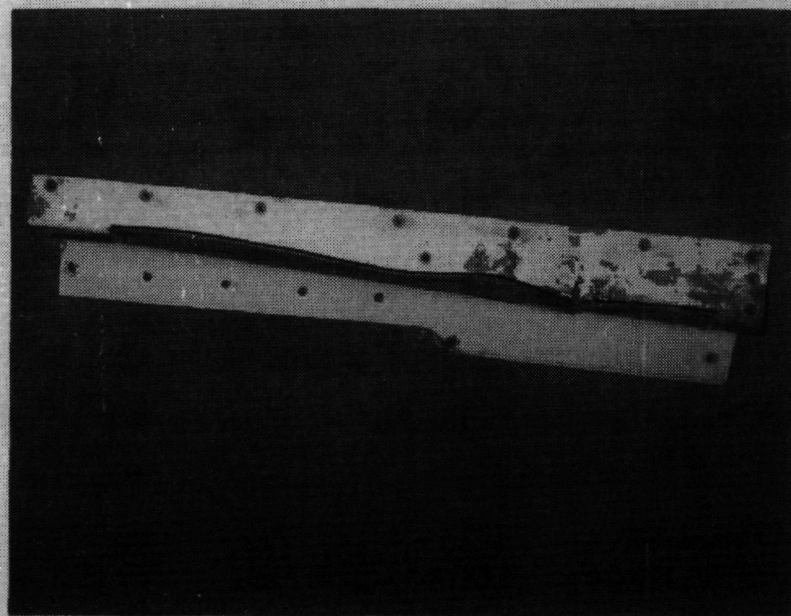
- 1) The panel weight was 1.02kg. (2 1/4 lbs.)
- 2) Paint is missing, with the Kevlar-49 surface exposed in extensive areas of the upper fillet. (Figure 14)
- 3) Fraying of fastener holes is visible from the exterior, but more noticeable viewed from the inner surface. Several elongated holes were noted which were the same ones observed in the 1975 inspection. No increase in elongation was noted. Fraying was more pronounced on the elongated holes. (Figures 15, 16, 17)
- 4) A slight gouged spot was noted on the upper forward area of the inner surface.

Figure 14. Eastern LH Underwing Fillet - Exterior Surface

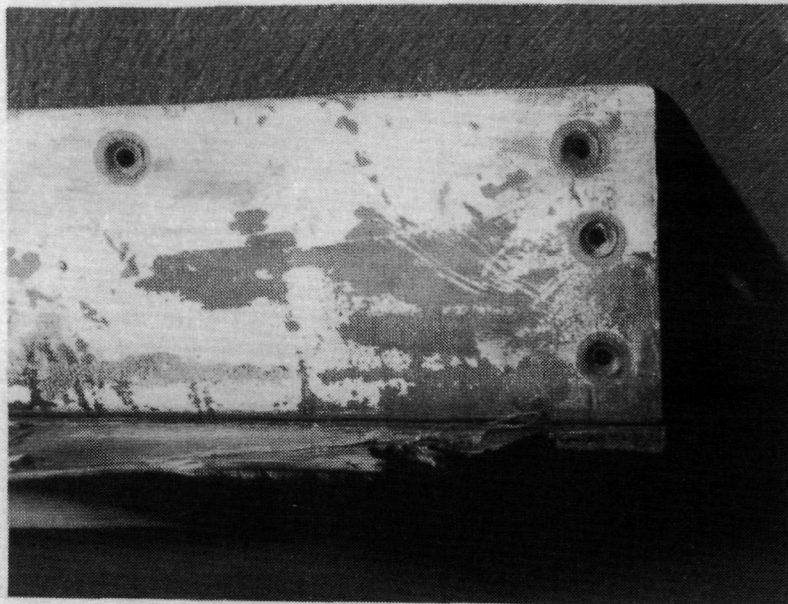
Figure 15. Eastern LH Underwing Fillet - Fastener Holes, Upper Aft Corner, from Exterior

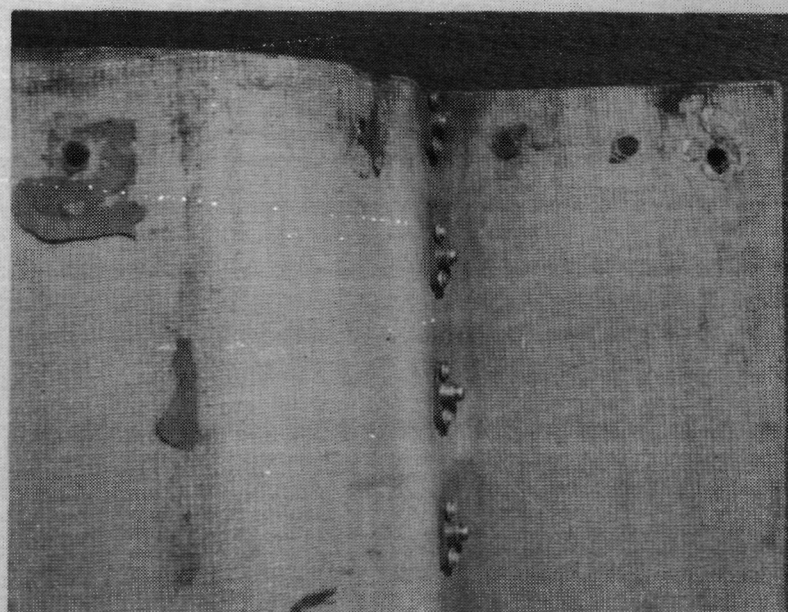
Figure 16. Eastern LH Underwing Fillet - Fastener Holes, Upper Aft Corner, from Inner Surface

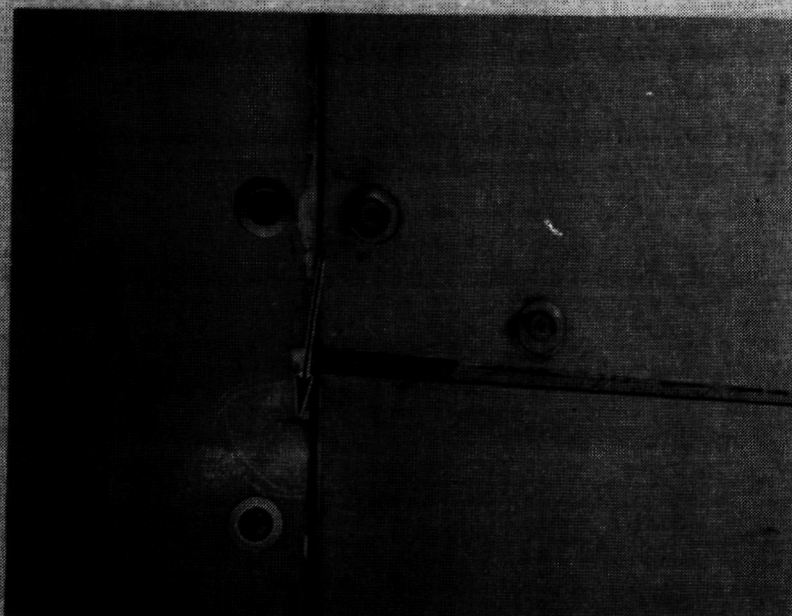
- 1) The following cracks observed in previous inspections were unchanged in appearance or extent:
  - 1.3 cm. (1/2 in.) crack at forward edge between 5th and 6th holes. No associated delamination. (Figure 18)
  - 0.6 cm. (1/4 in.) crack near exact center (may or may not be into skin) with scratch through paint to flame spray extending upward 20.3 cm. (8 in.). No delamination.
  - 0.3 cm. (1/8 in.) ding lower center - definitely into skin. No delamination.
  - 0.8 cm. (5/16 in.) crack in lower forward area - with slight associated delamination. 1.6 cm. (5/8 in.)
  - 0.3 cm. (1/8 in.) crack aft center - no associated delamination.

Figure 18. Eastern RH Wing-Body Fairing - Crack in Forward Edge 0.3 cm. (1/8 in.) Length

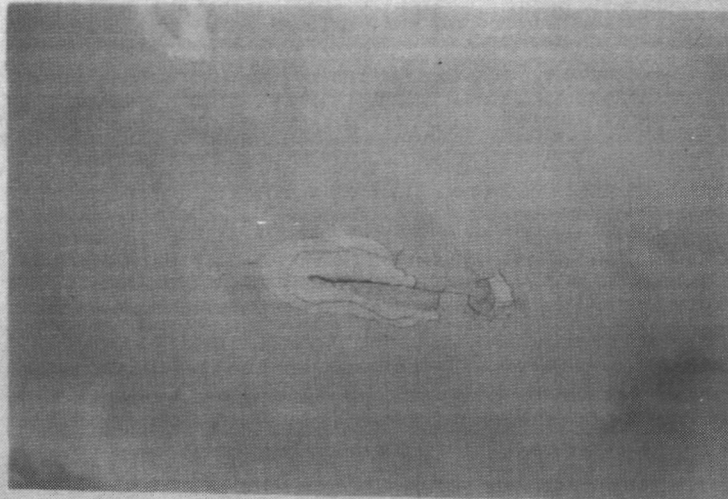
- 1) The panel weight was 697 kg (15 3/8 lbs.). Previous panel weight measured in 1976 was 672 kg (14.81 lbs.).
- 2) A 3.2 cm. (1 1/4 in.) crack was noted in the upper, aft area. (Figure 19). This crack has not grown or delaminated further since it was first observed in 1975. No other cracks were observed, and a 1.3 cm. (1/2 in.) crack observed in 1976 was apparently only in the original paint layer and had been repainted.

Figure 19. Air Canada LH Wing-Body Fairing - Crack, Exterior Surface, 3.2 cm (1-1/4 in.) Length

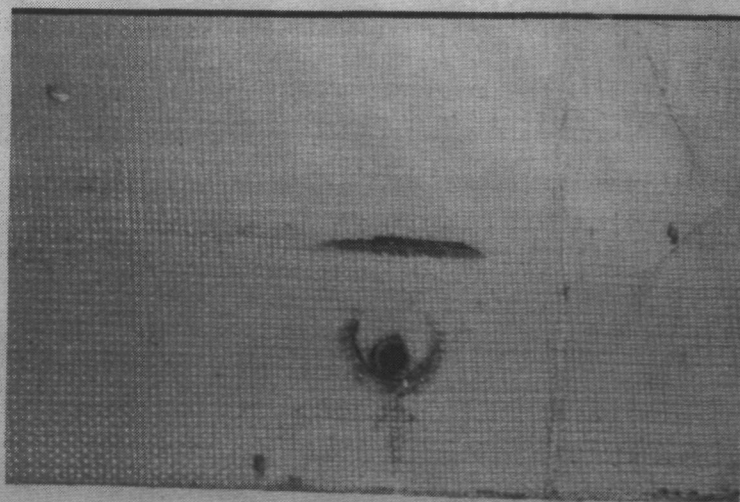
- 3) Fastener holes appeared slightly frayed as viewed from exterior and inner surfaces, with a greater degree of fraying noted on the bottom edge holes as viewed from the inner surface. (Figure 20). Slight hole elongation was observed on all fastener holes on the bottom edge, plus two other holes on the forward and top edges.

Figure 20. Air Canada LH Wing-Body Fairing - Close-Up of Fastener Holes on Bottom Edge, Inner Surface

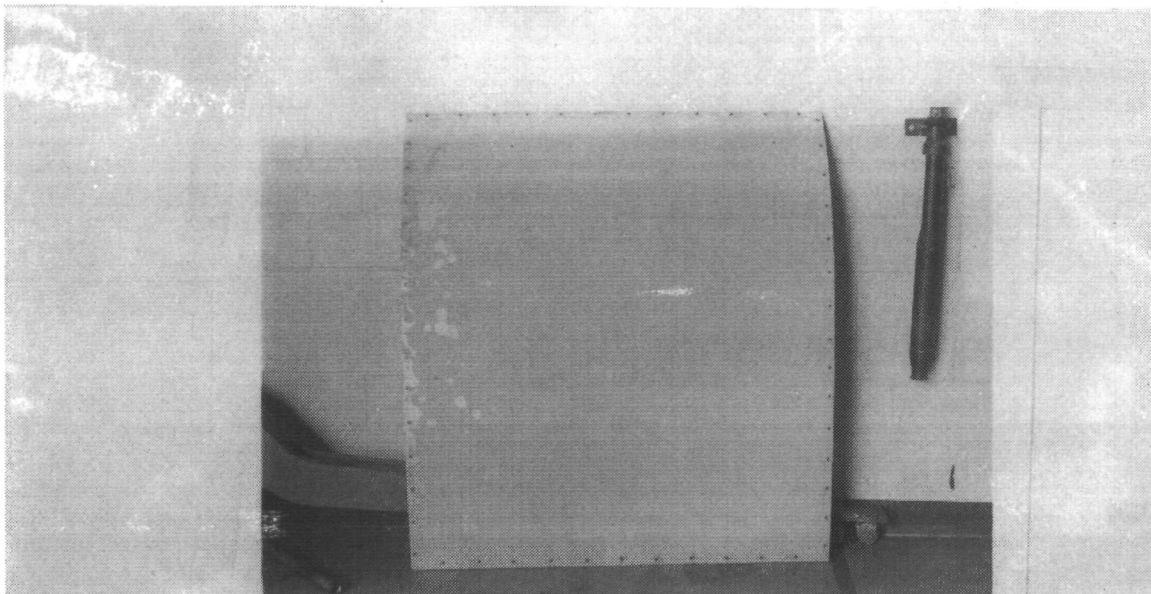
- 4) Extensive paint loss was observed on edges and upper forward area, but no associated damage in the part. (Figure 21).
- 5) No defects or damage were observed on the inner surface.

Figure 21. Air Canada LH Wing-Body Fairing - Exterior

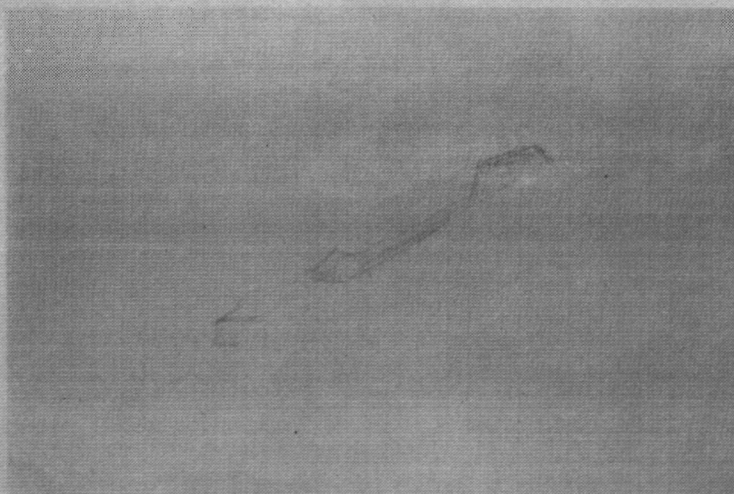
removed for the first time for inspection, had three skin-core disbond areas. This condition probably is the result of processing errors since all the other panels have been free of skin-core disbonds. This condition will be monitored in future inspections for any increase in disbond area.

- 3) Two disbonded areas were observed on the inner surface in the upper center area; one area was irregularly shaped 12.7 cm (5 in.) long varying from 0.6 cm (1/4 in.) to 1.3 cm (1/2 in.) width; and a nearby area 2.5 cm (1 in.) by 1.3 cm (1/2 in.). (Figure 22). An area 26.7 cm (10 1/2 in.) by 3.2 cm (1 1/4 in.) slightly below the delaminated areas appeared to have been sanded. The sanding appeared to be on an overlay which may have been a repair patch. A third disbond was noted in the lower, aft area 10.2 cm (4 in.) long varying from 1.3 cm (1/2 in.) to 2.2 cm (7/8 in.) wide. The inner surface of this panel had not previously been inspected. F-22

Figure 22. Air Canada RH Wing-Body Fairing - Outline of Disbond Areas on Inner Surface - 12.7 cm (5 in.) by 1.3 cm (1/2 in.); and 2.5 cm (1 in.) by 1.3 cm (1/2 in.)

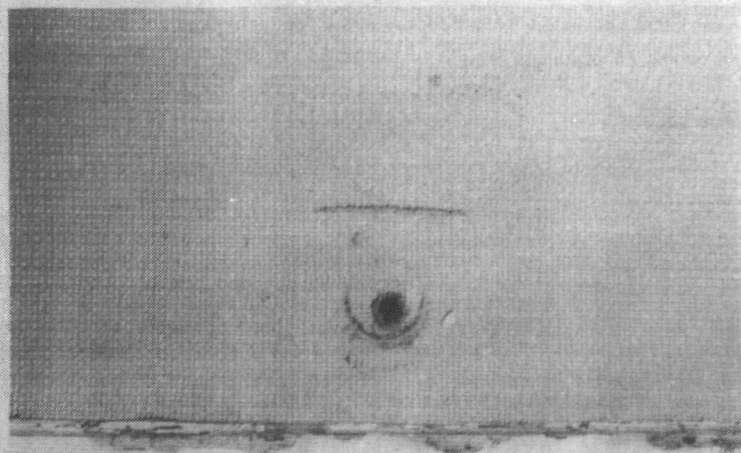
- 4) Slight fraying of fastener holes was observed on the upper, aft, and forward edges as viewed from either surface. A greater degree of fraying was observed on the bottom edge fastener holes. Several fastener holes were elongated to a slight degree on the bottom and aft edge. (Figure 23). One hole in the lower, forward, corner was elongated to 1.1 cm (7/16 in.) maximum dimension from the original 0.5 cm (3/16 in.) diameter. All lower edge holes had a slight convex deformation of the laminates around them with markings from the fastener heads. F-23

Figure 23. Air Canada RH Wing-Body Fairing - Close-Up of Fastener Holes, Bottom Edge, from Inner Surface

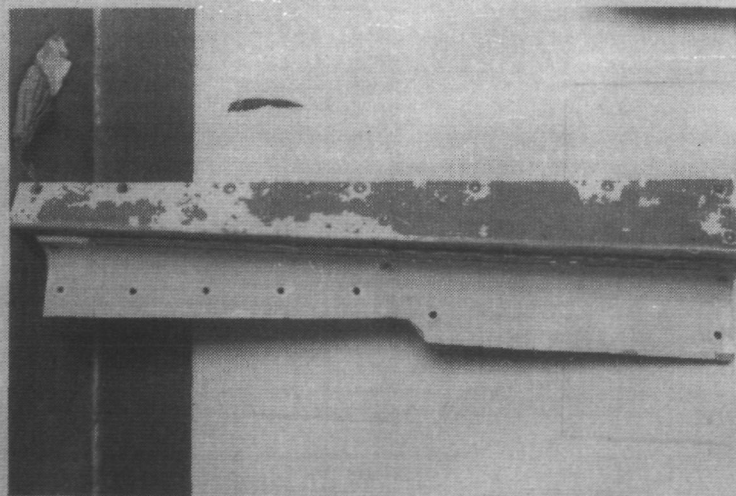
- 2) No surface damage or defects were noted on either surface but considerable paint loss was observed in the upper exterior surface with the Kevlar-49 surface exposed. (Figure 24). F-24
- 3) Slight fraying was observed on all fastener holes. Hole deformation was noted on four holes in the lower area, and seven holes in the upper area. (Figure 25). Four of these were only slight deformation, but the others had maximum dimensions of 0.6 cm (1/4 in.), and 1.1 cm (7/16 in.) in some cases from the original 0.5 cm (3/16 in.) diameter. This represented some increase in the incidence of hole deformation over that observed in 1976, specifically three of the holes in the lower area which were noted to have a slight deformation in 1977, and three of the holes in the upper area observed to have deformation up to 1.1 cm (7/16 in.) in 1977. F-25

Figure 24. Air Canada LH Underwing Fillet - Exterior Surface

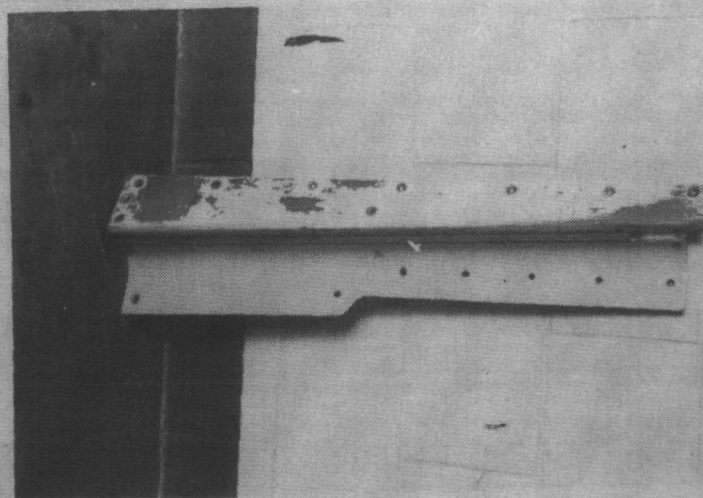
- 1) The panel weight was 0.85 kg (1 7/8 lbs.).
- 2) No damage or defects were noted on either surface, but considerable paint loss was observed on the upper area with the Kevlar-49 surface exposed. (Figure 26). F-26
- 3) Slight fraying was observed around all fastener holes. Hole deformation was noted on eight holes in the upper area, four to a slight degree and the others deformed to a maximum dimension of 1.1 cm (7/16 in.) (Figure 27) from the original 0.5 cm (3/16) diameter. One hole on the lower edge was slightly elongated. This represented an increase in the observed number of elongated holes since their F-27

Figure 26. Air Canada RH Underwing Fillet - Exterior Surface

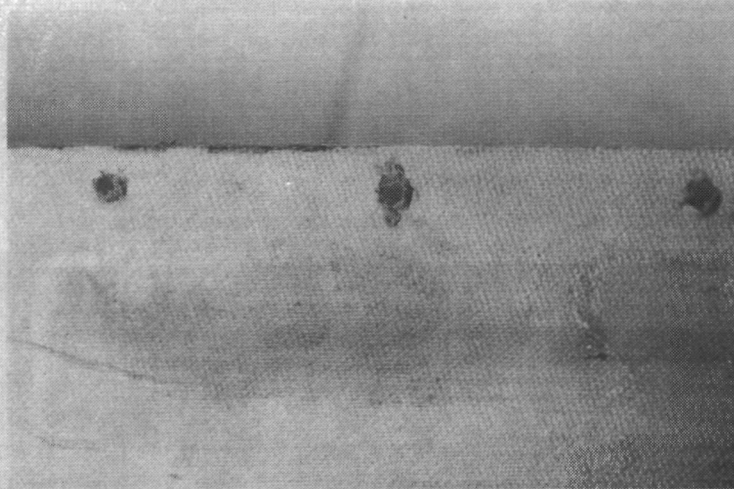
- 1) The panel weight was 2.89 kg (6 3/8 lb.).
- 2) No surface damage or defects were noted. (Figure 28).
- 3) Extensive fraying of fastener holes was observed on all edges as viewed from both surfaces. (Figure 29). Loose Kevlar-49 fibers were noted inside holes. The intercostal holes through the core area were more frayed than holes in the edge laminate. (Figure 30). Elongation was noted only to a very slight degree on three holes along the bottom edge.

Figure 29. Air Canada LH Aft Engine Fairing - Frayed Fastener Holes, Bottom Edge, from Inner Surface

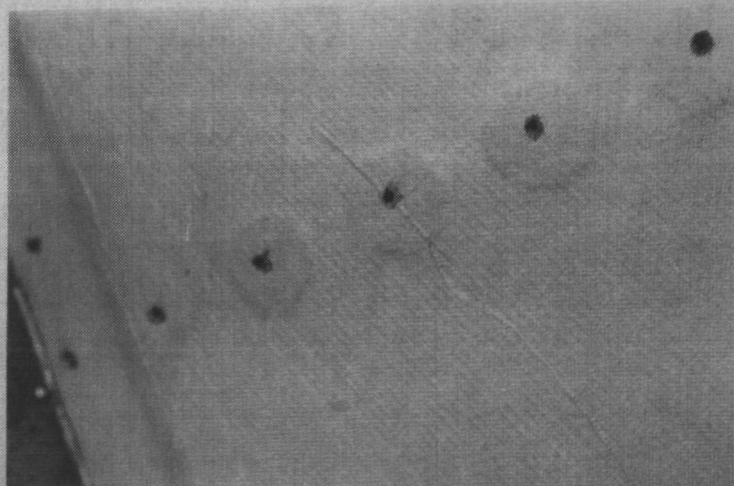
Figure 30. Air Canada LH Aft Engine Fairing - Frayed Intercostal Holes Through Core Area

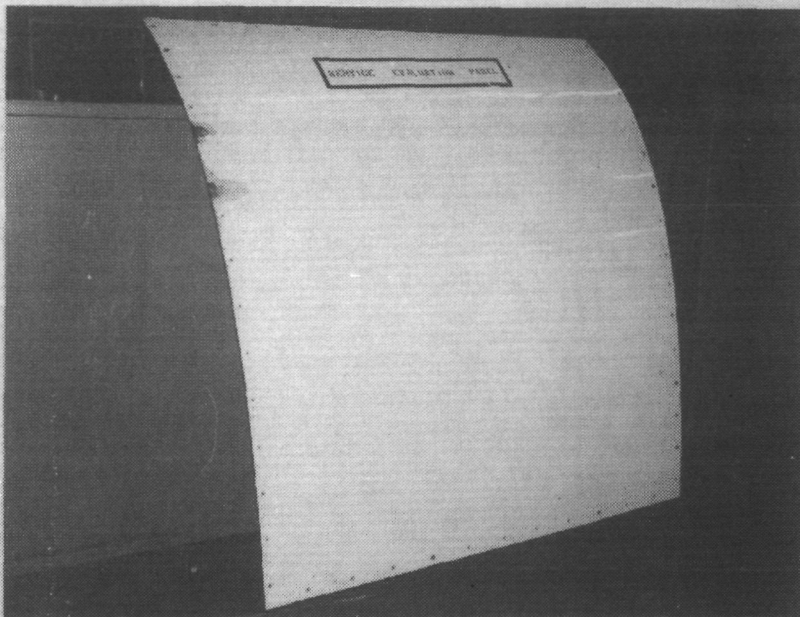
- 1) A small crack 0.3 cm (1/8 in.) in length was observed in the center, aft area. This crack had not been previously observed.
- 2) The outer and inner surfaces showed no other defects or damage, although some paint loss was observed on the forward edge. (Figure 31). F31
- 3) Slight fraying of fastener holes was visible from the inner surface only. (Figure 32). Six holes were observed to have deformation with a maximum dimension of 0.55 cm (7/32 in.) to 0.6 cm (1/4 in.) from the nominal 0.5 cm (3/16 in.) diameter. These were randomly located on the top, forward, and bottom edges. F32

Figure 31. TWA LH Wing-Body Fairing - Exterior Surface

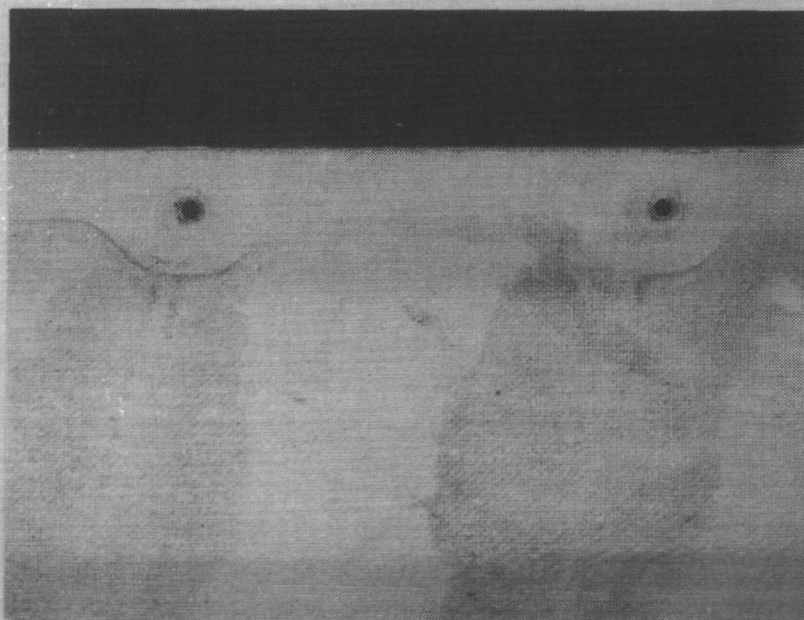
Figure 32. TWA LH Wing-Body Fairing - Typical Fastener Holes Viewed from Inner Surface

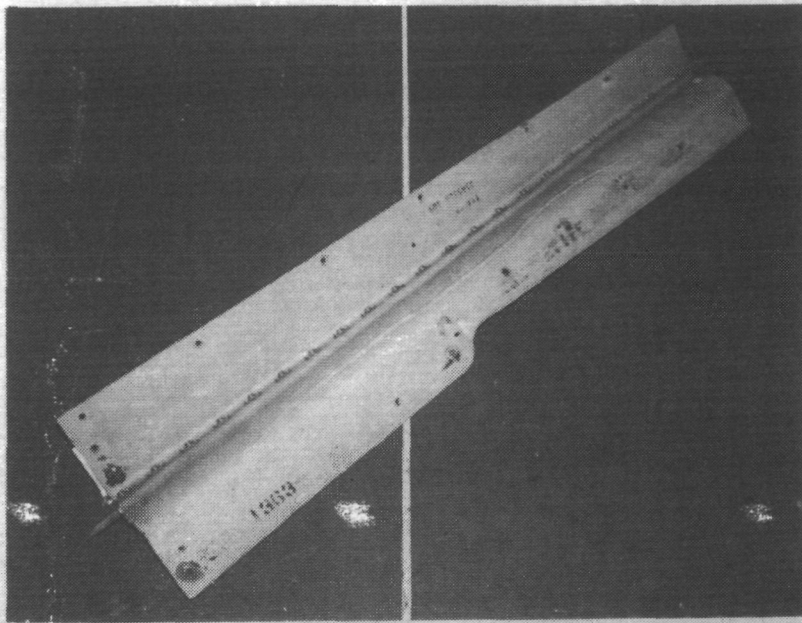
- 1) No damage or defects were observed on either the inner or outer surfaces. (Figure 33). A paint loss area on the upper surface had been repainted since the 1976 inspection. F33
- 2) Extensive fraying was visible from both the inner and outer surfaces on several fastener holes in the upper fillet sections, which were also slightly elongated. (Figure 34). These included three holes F34

Figure 33. TWA LH Underwing Fillet - Inner Surface

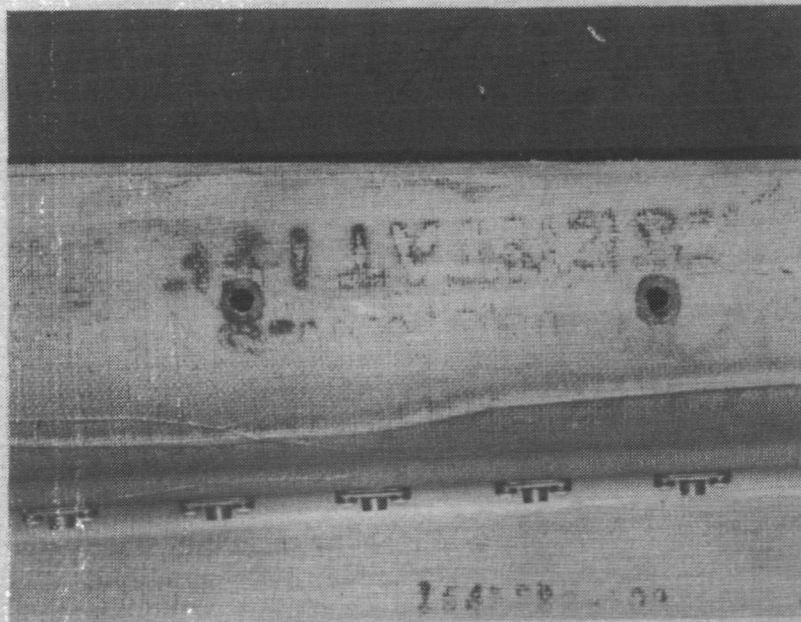
Figure 34. TWA LH Underwing Fillet - Fastener Holes on Upper Edge Viewed from Inner Surface

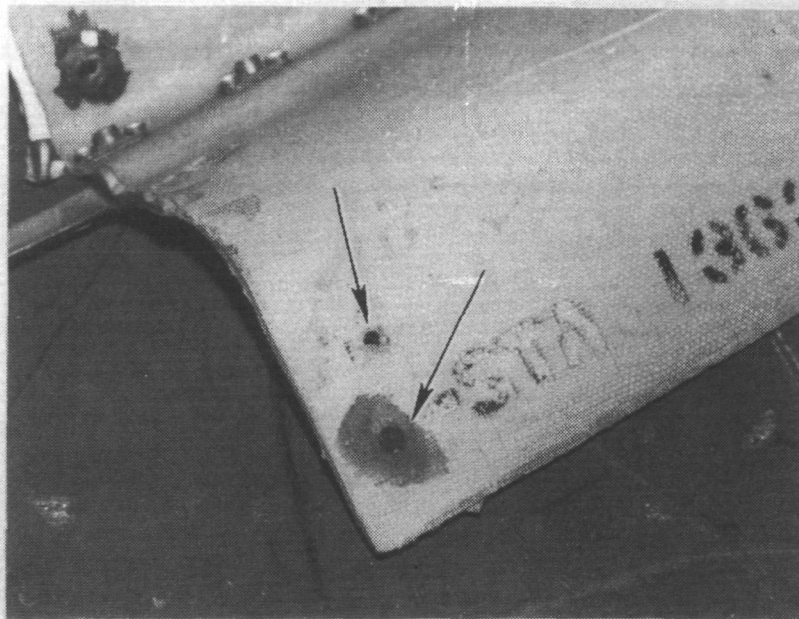
Figure 35. TWA LH Underwing Fillet - Filled and Relocated Fastener Holes

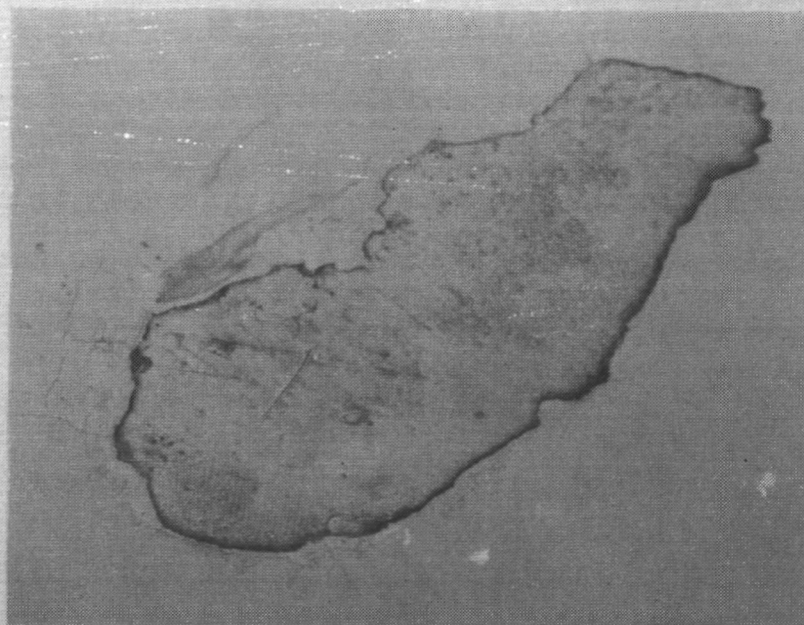
Figure 36. TWA RH Aft Engine Fairing -- Repainted Area with Possible Skin Damage

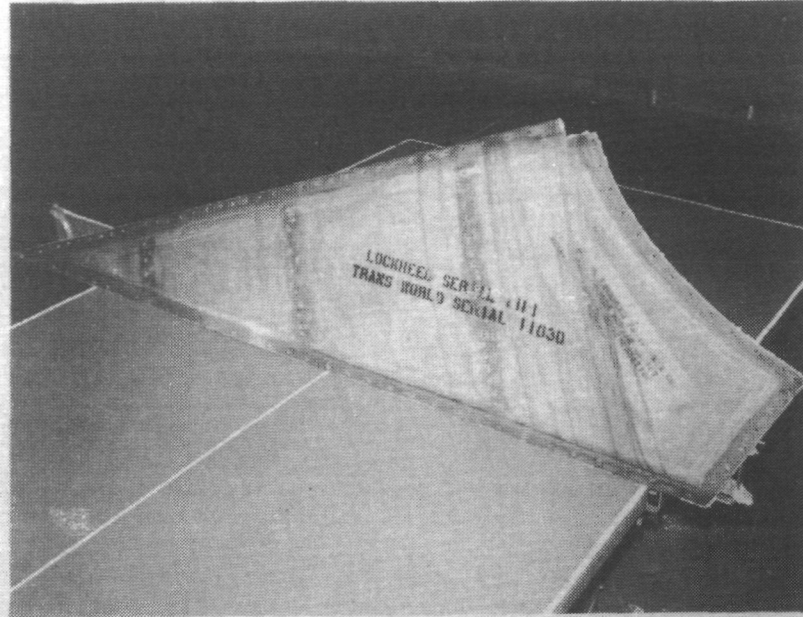
- 1) A paint loss area observed in 1976 had been repainted. (Figure 36). The paint had a rough, porous appearance, and two possible damage areas were observed in the center of the painted area. One was 0.3 cm (1/8 in.) diameter, and the other was 0.5 cm (3/16 in.) diameter. There was no associated delamination.
- 2) The inner surface was free of defects or damage, with the vapor barrier coating applied during reinstallation in lieu of Tedlar Film showing no defective areas or disbonds. (Figure 37).

Figure 37. TWA RH Aft Engine Fairing - Inner Surface with Vapor Barrier Coating

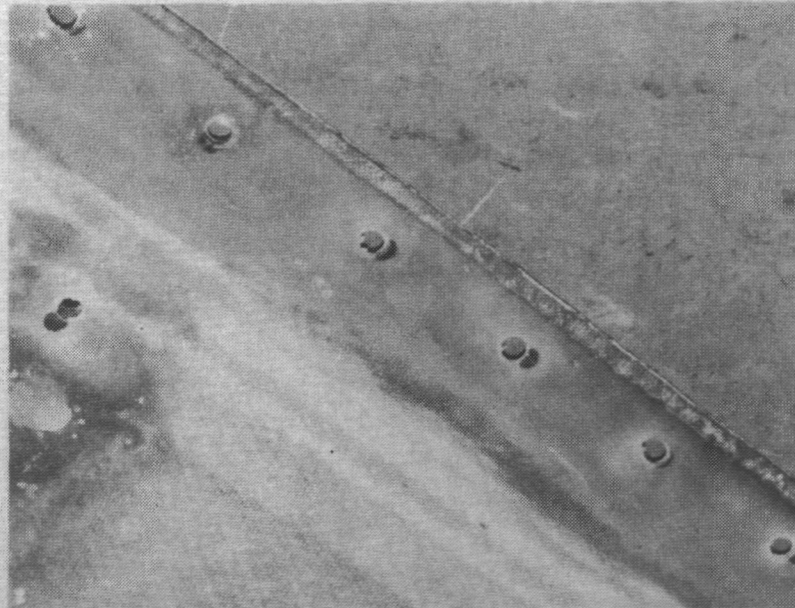
- 3) Very slight fraying of fastener holes was visible from the inner surface only. (Figure 38). Deformation was observed on a large number of holes, approximately 2/3 of the total. (Figure 39). The holes were typically elongated from 0.55 cm (7/32 in.) to 0.7 cm (9/32 in.) maximum dimension from the nominal 0.5 cm (3/16 in.) diameter. Three of the intercostal holes were also elongated to 0.6 cm (1/4 in.). These were all on the aft intercostal.

Figure 38. TWA RH Aft Engine Fairing - Fastener Holes Viewed from Inner Surface

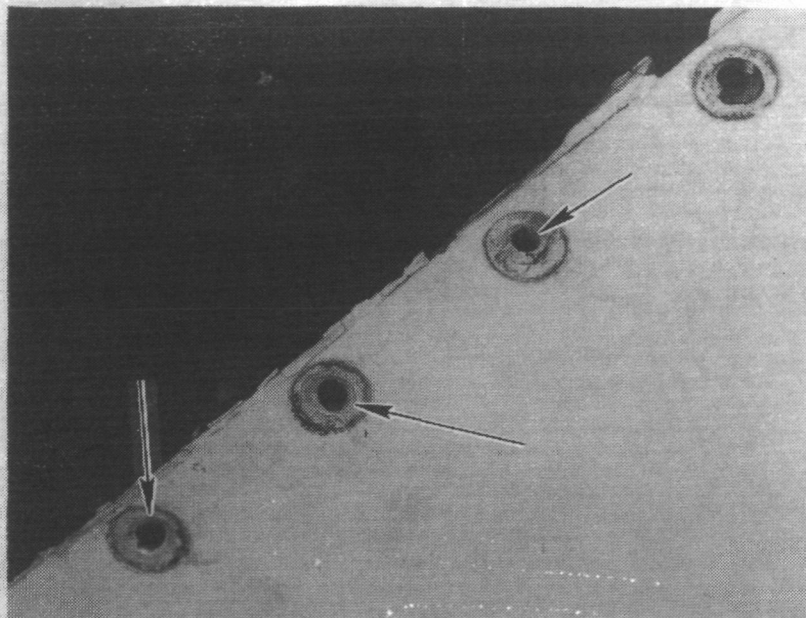
In one instance, hole deformation has been observed on parts other than the underwing fillets, and these are the TWA aft engine fairings. These fairings, as described in the Second Annual Report (Ref. <sup>3</sup>3), required relocation of all fastener holes during reinstallation. The holes were filled with a chopped glass filled epoxy, and a layer of epoxy impregnated 120 glass cloth was applied to both surfaces. Many holes were redrilled through the filled area, and these holes show a significantly greater degree of elongation than any holes drilled through a solid Kevlar-49 laminate. This condition, while not affecting part performance or requiring corrective maintenance, does indicate an inadequacy of the repair; and does not reflect on the performance of Kevlar-49.

Figure 39. TWA RH Aft Engine Fairing - Fastener Holes Viewed from Exterior, Showing Elongation

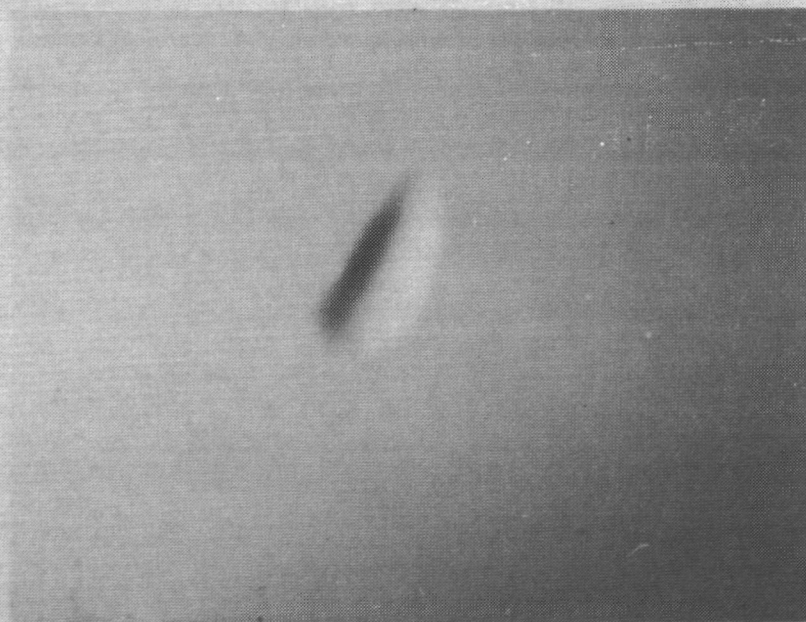
A more extensive damage condition was observed on the TWA right-hand wing-body fairing. This is a fairly deep concave depression and skin-core disbond, but with no associated crack or surface damage, which does not appear to be the result of impact damage. This condition is probably related to a repair made in this part during its reinstallation on Ship 1111 (Ref. 3). This repair was not documented, but apparently consisted of replacement of a damaged core area, extending partially through the core thickness, with a microballoon filled potting compound. Crushing of this potting compound under in-service conditions is a possible explanation of this condition. In any case, this does not appear to be a Kevlar-49 related problem, but as it is highly visible it will be carefully monitored in future inspections.

Figure 40. TWA RH Wing-Body Fairing - Concave Depression with Disbond, Exterior Surface

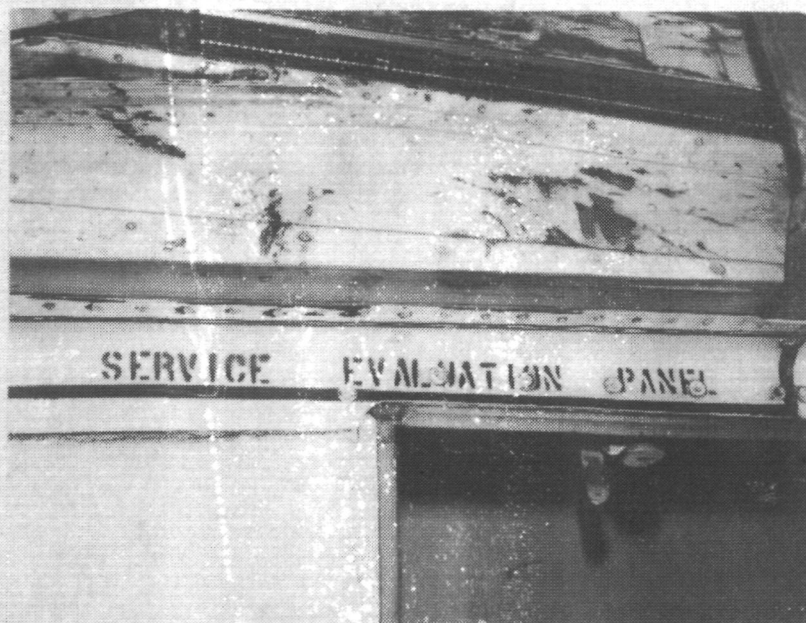
- 1) No damage or defects were visible on the exterior surface. (Figure 41). The lower aft edge had a bulged appearance indicating possible misalignment. No fasteners showed evidence of misalignment, however.

Figure 41. TWA RH Underwing Fillet - Exterior Surface on Aircraft

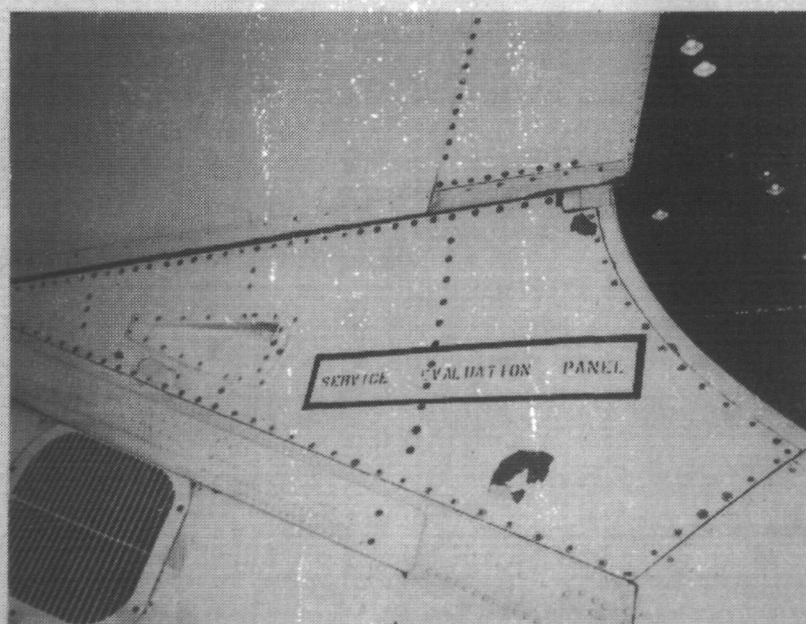
Figure 42. TWA LH Aft Engine Fairing - Exterior Surface on Aircraft Showing Paint Loss Areas
